1. Project Name: Kahului DDH
2. Date of Inspection: May 13, 2005
3. Inspection Personnel:

O & M INSPECTION REPORT FOR NAVIGATION PROJECTS

Honolulu Engineer District

KAHULUI HARBOR, MAUI, HAWAII

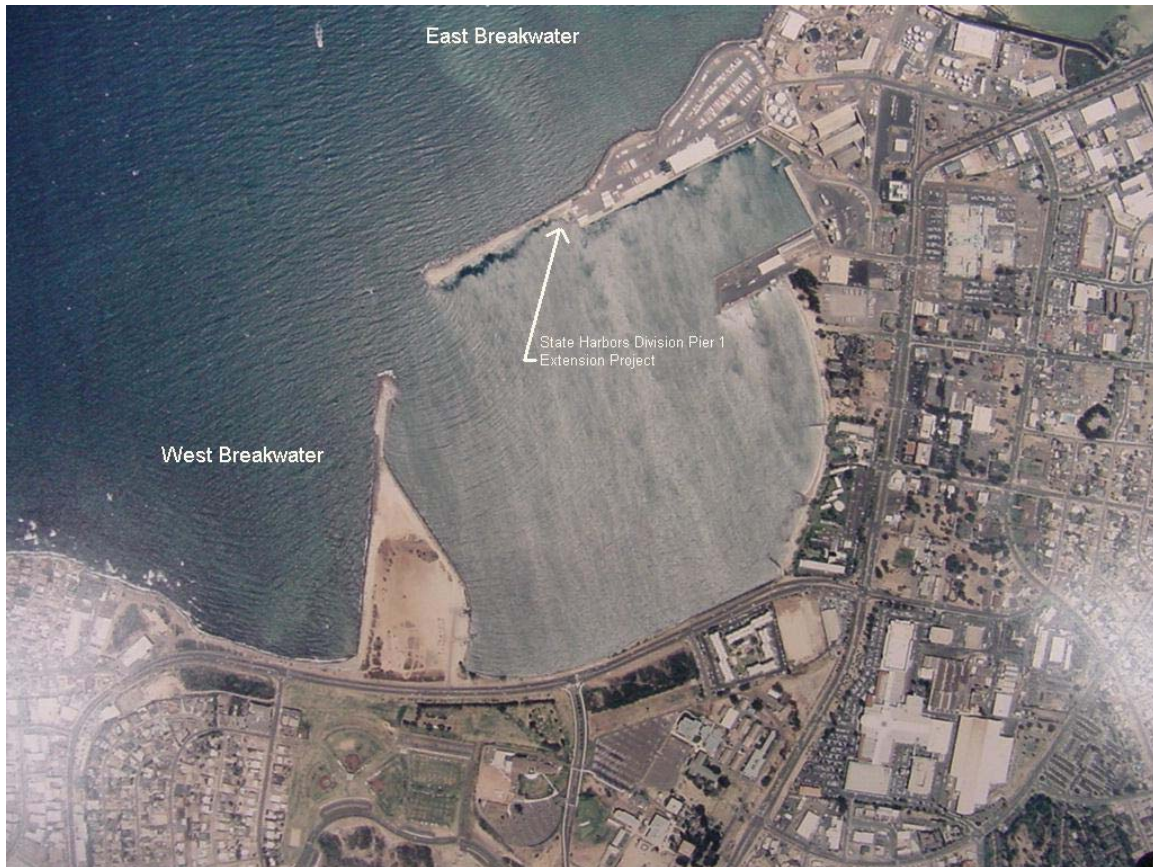
Prior to the inspection I met with Mr. Stephen Pfister, Harbor Master, Kahului DDH, 873-3354. Pfister said the only recent work was the completion of the walkway / dolphin adjacent the east breakwater and the current COE's dredging / construction at the Kahului SBH. Following the meeting an inspections of the East B/W, and the West B/W were conducted. See photo below:

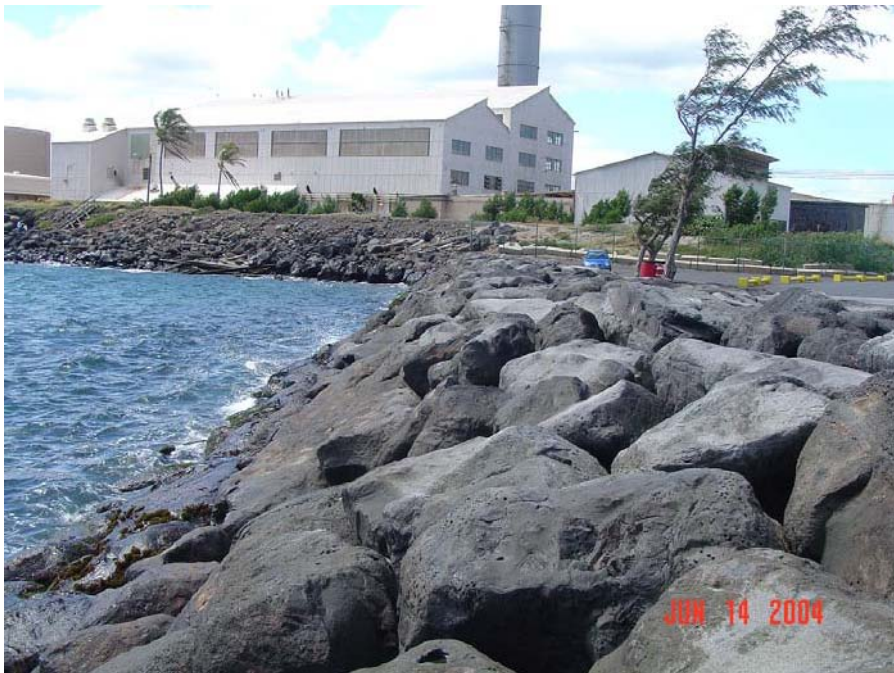
d. Sta 3+20, Curve #1, Overview of Oceanside looking back toward root.

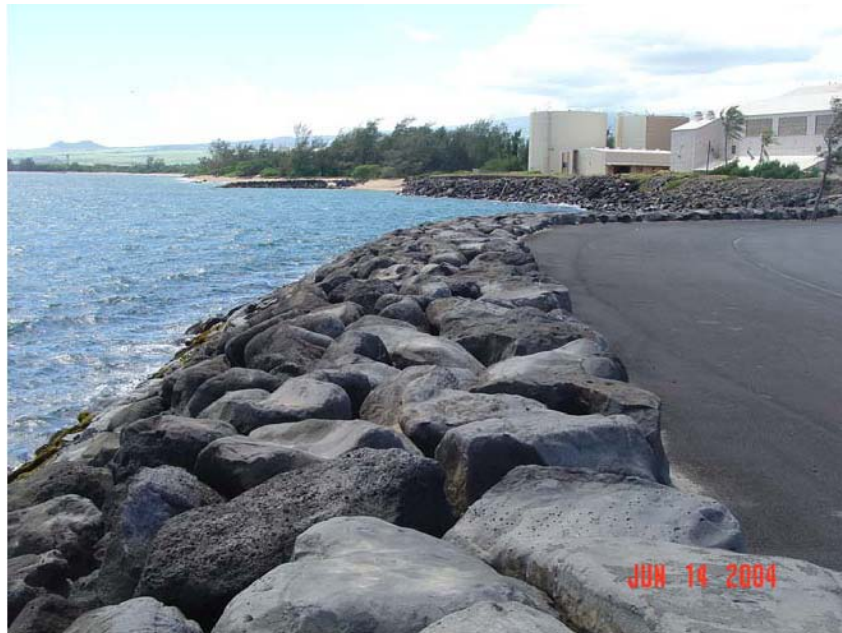
e. Sta 4+90, Lightpole # 15, Overview facing root.

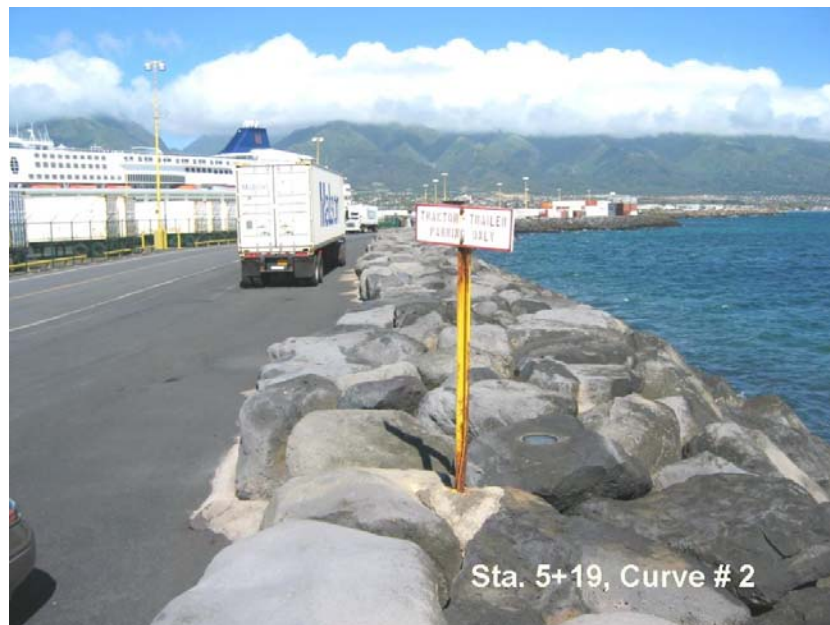
f. Sta 4+90, Overview looking toward head.

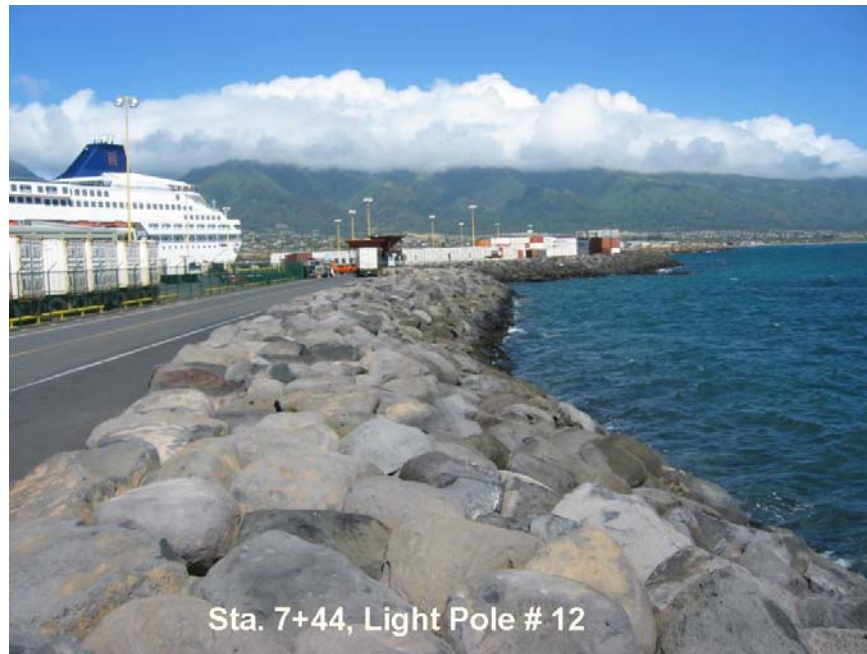
g. Sta 7+44 (Lightpole 12), Overview facing head.

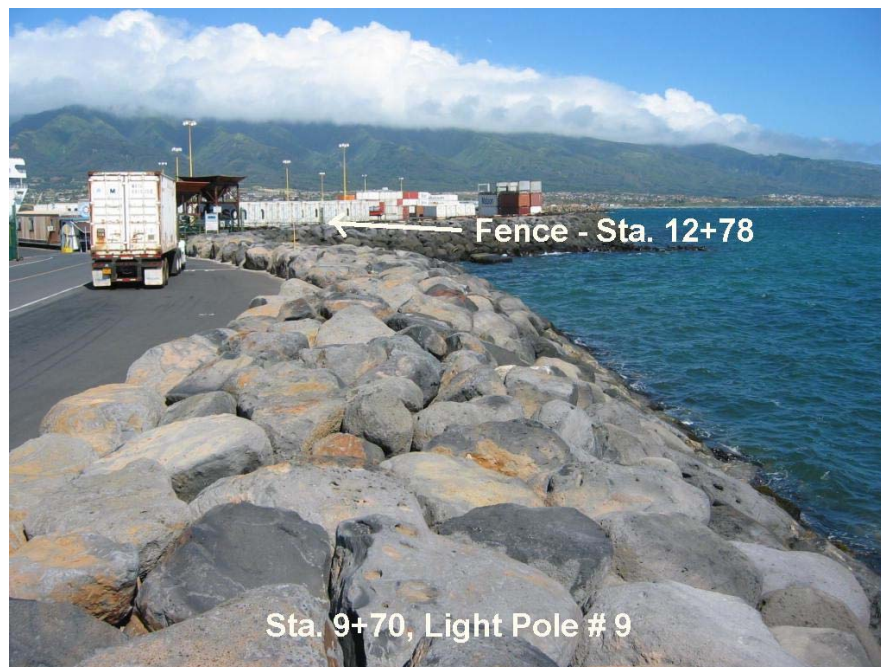
h. Sta. 9+70 (Lightpole 9), Overview facing head.

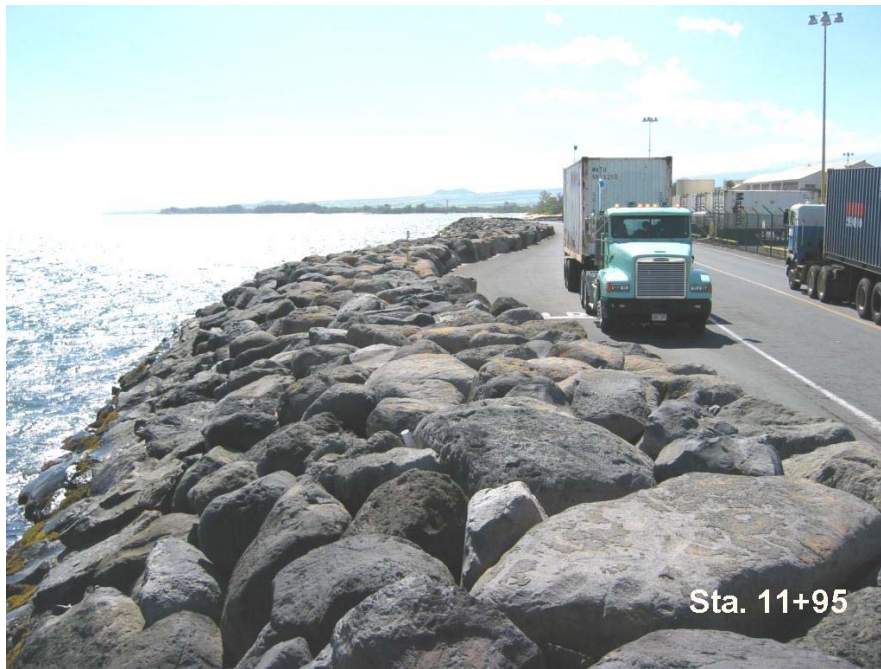
i. Sta 11+95, End of new repair. Overview facing root.

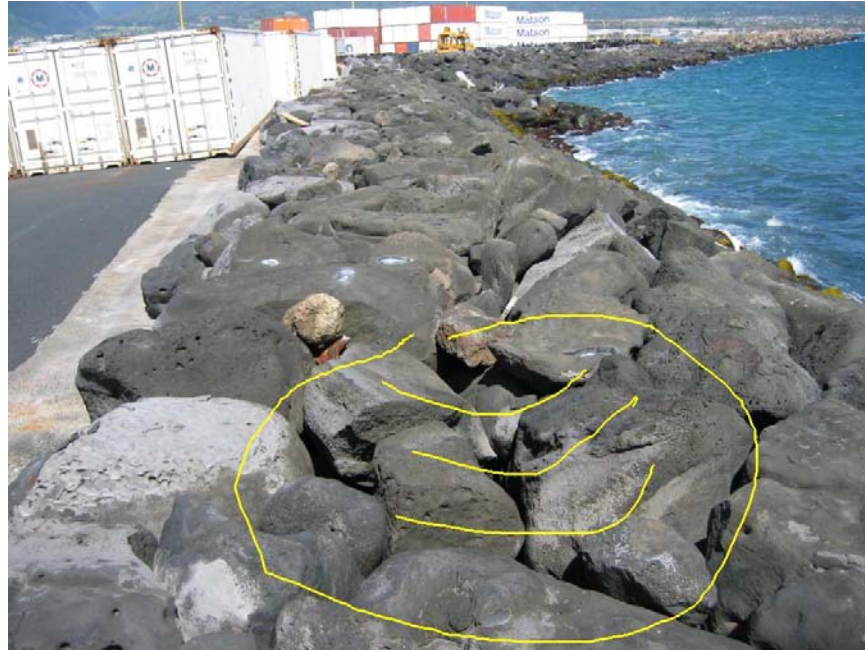
n. Sta. 17+05, Crest, Minor Settling.

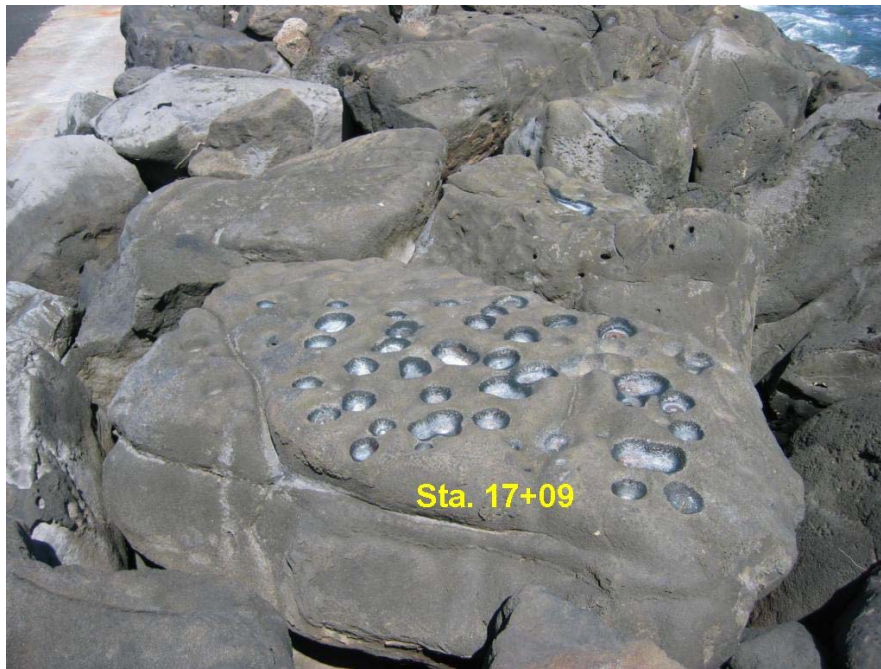
o. Sta 17+09, Distinguishable stone noted for measurement purposes only.

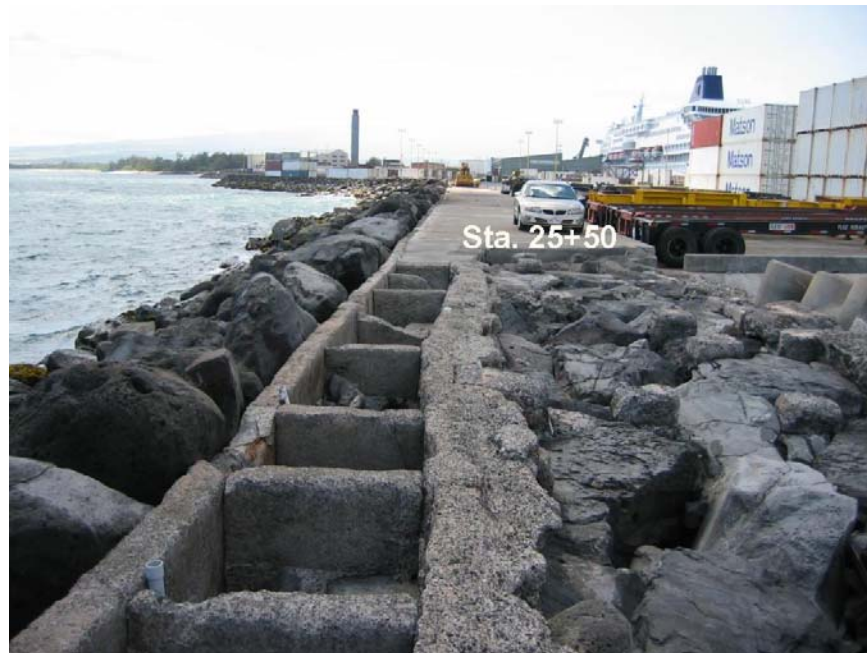
u. Sta 26+26 (begin ribcap), State Harbor's Extension of Pier 1, HS of B/W.

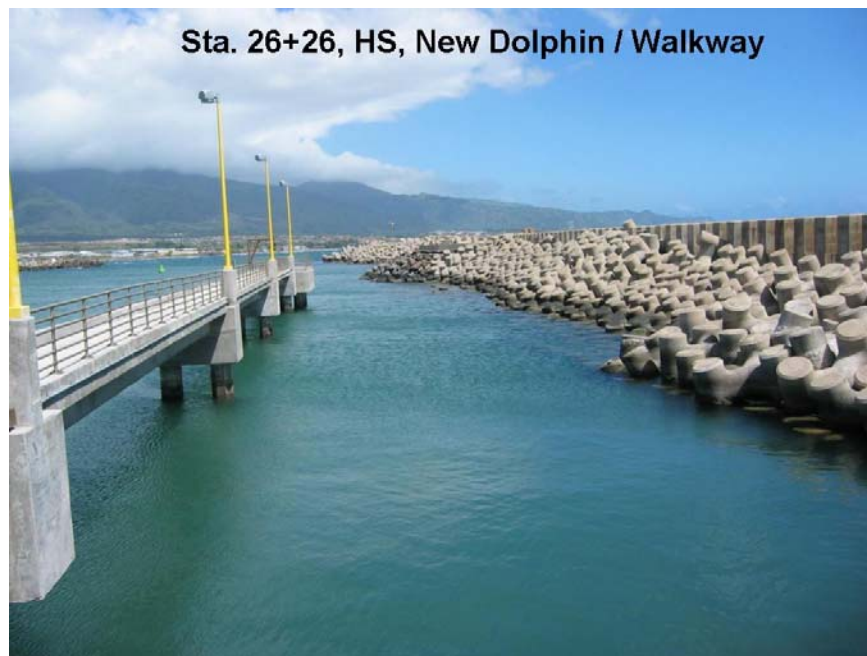
v. Sta. 26+26, HS, New dolphin and walkway adjacent B/W.

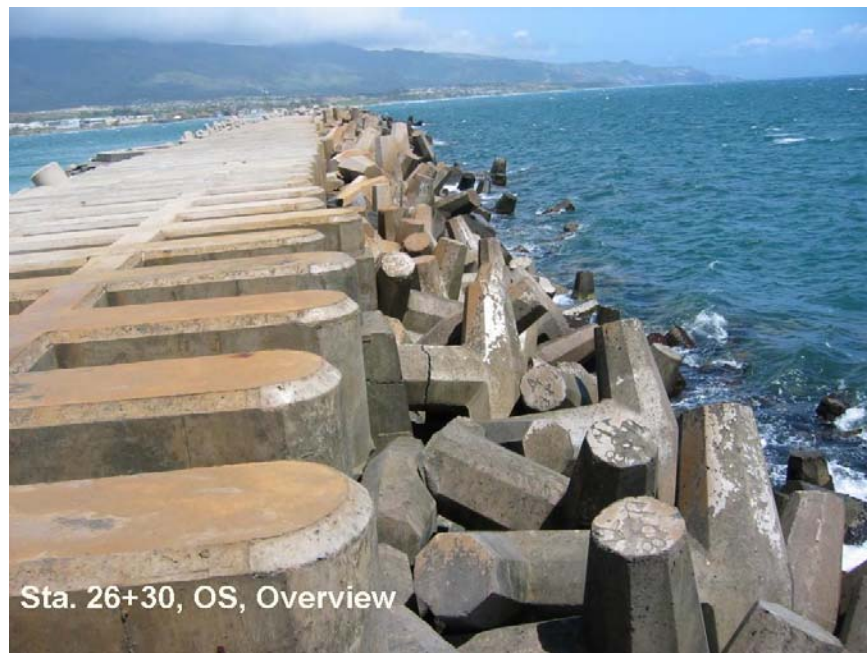
z. Sta 26+30, OS, Overview of steepened side slope.

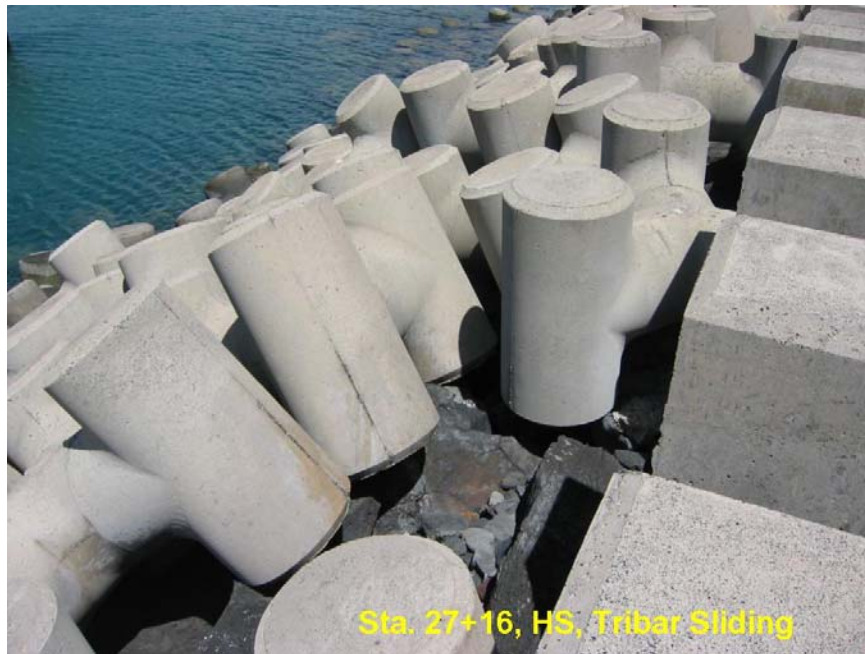
cc. Sta. 27+16 (Rib 16), HS, Tribar separation from ribcap.

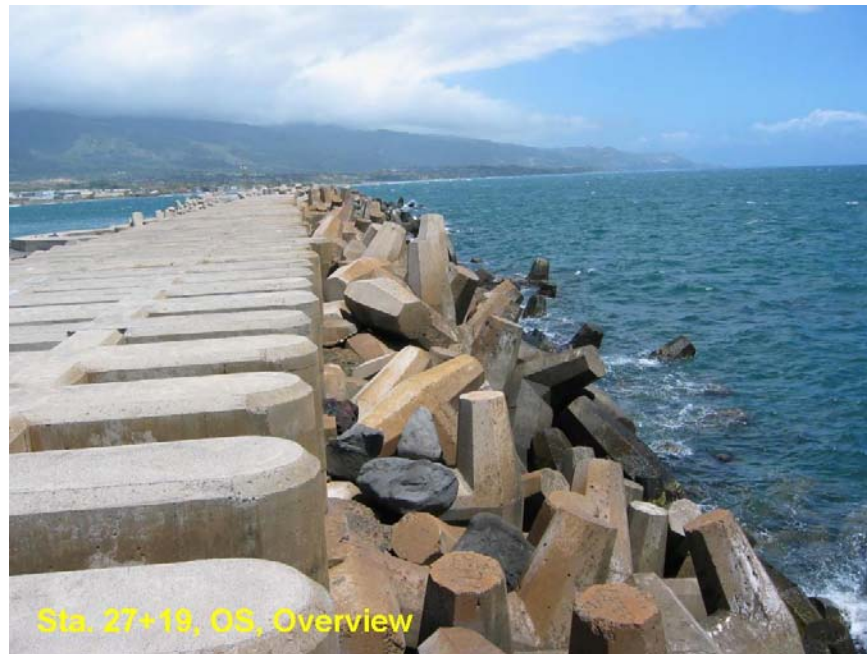
ee. Sta 27+19, OS, Overview of side slope.

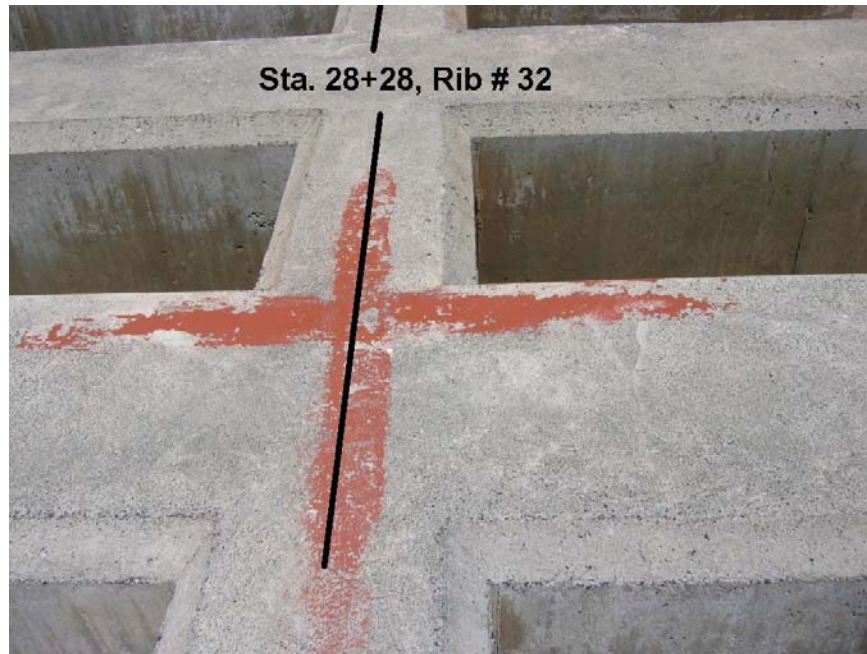
ii. Sta 28+28, Rib # 32, Red cross painted.

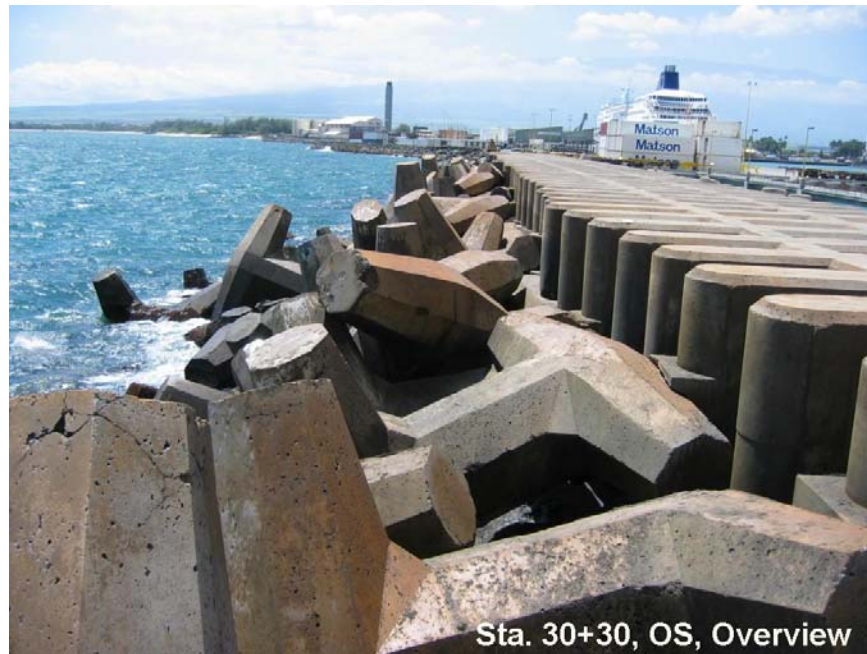
kk. Sta 30+00, OS, Overview.

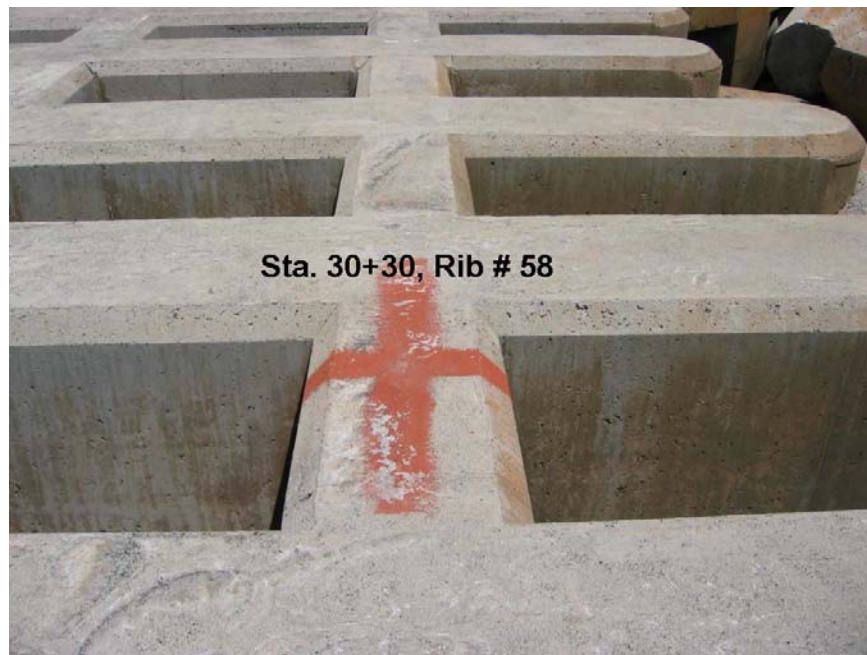
ll. Sta 30+30 (Rib 58), Red cross painted.

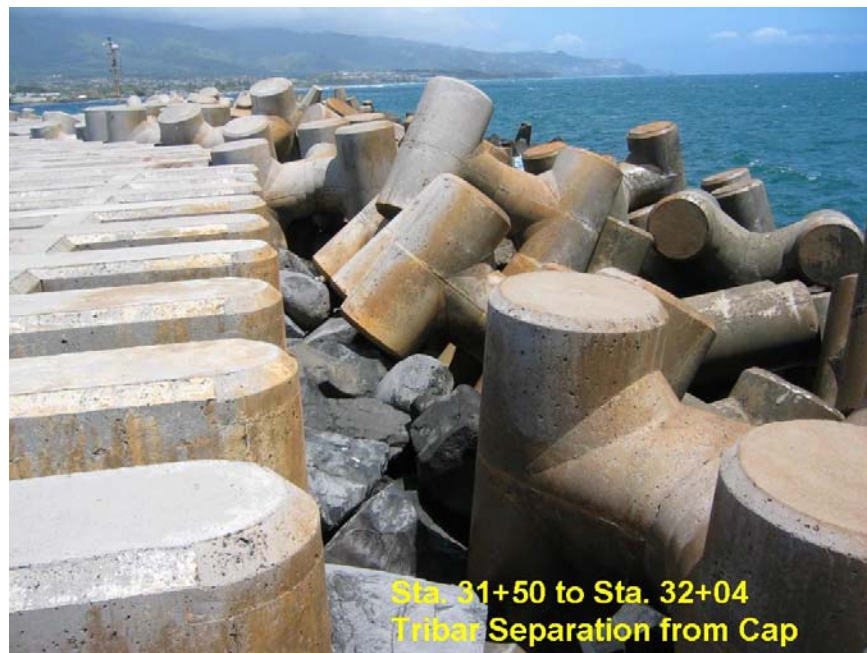
nn. Sta 31+50 (Rib 77) to Sta 32+04 (Rib 86), 8 ft Tribar separation from ribcap.

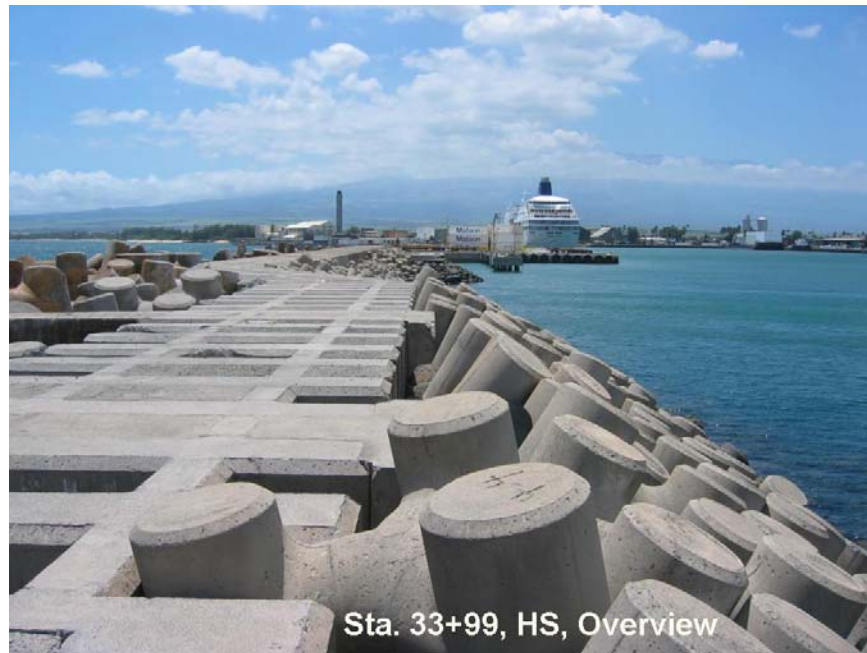
ss. Sta 33+99, HS, Overview.

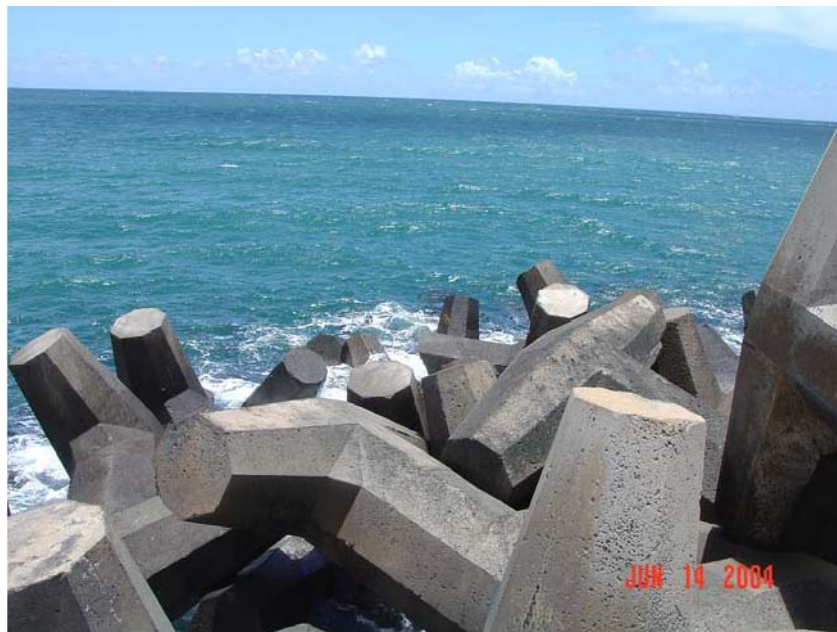
vv. 0S degree view from head.

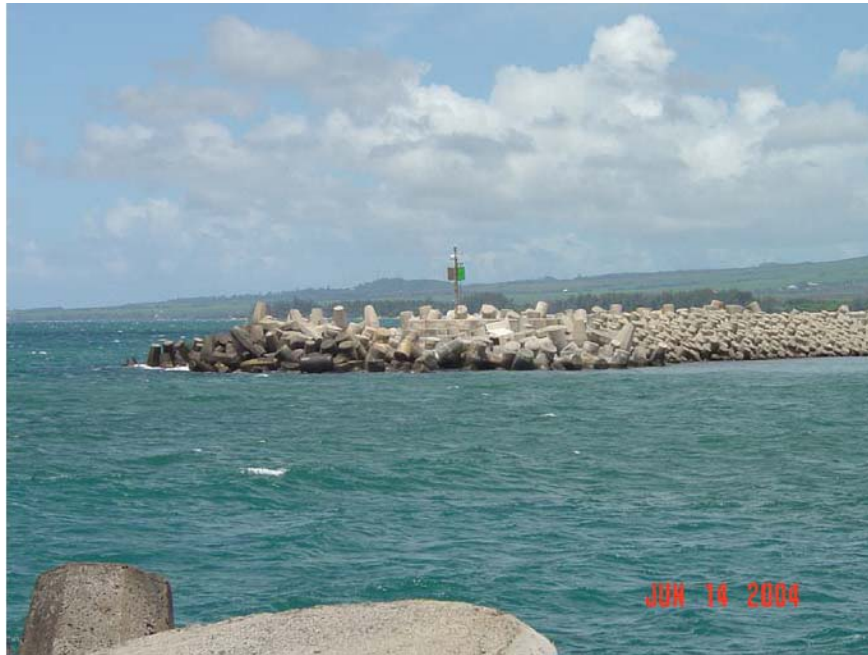
ww. View of East Breakwater head.

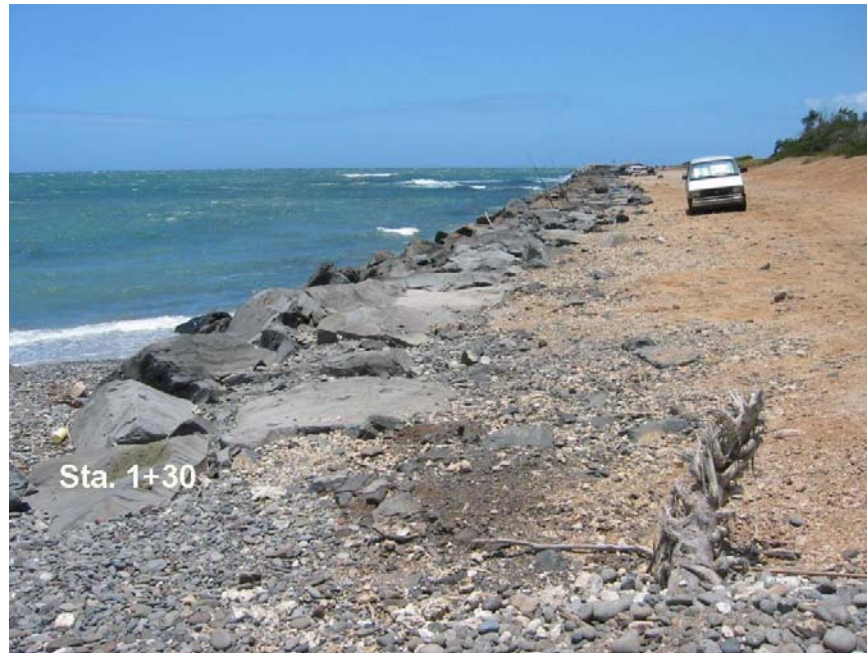
a. Overview of structure @ Sta. 1+30

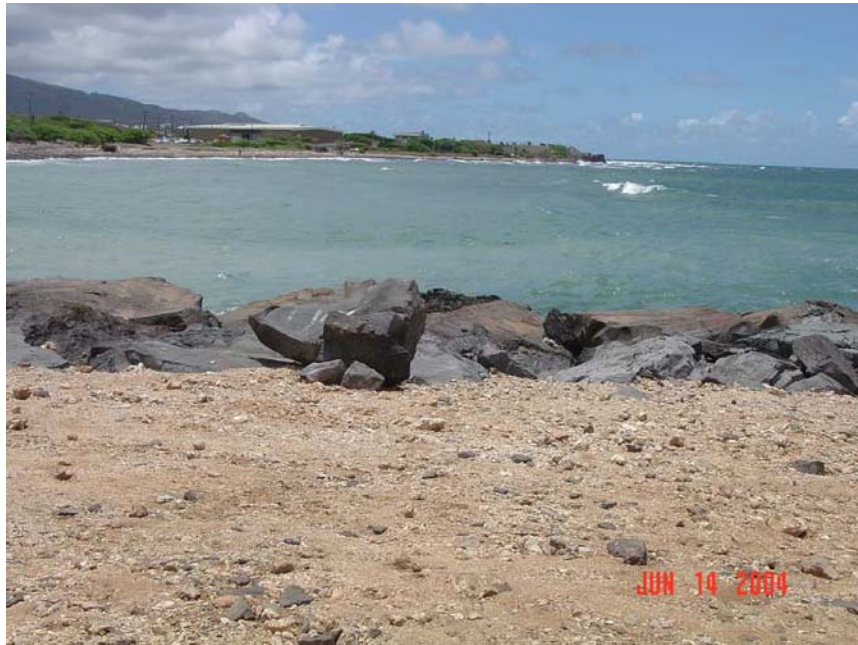
c. Sta 2+70, OS, Flipped armor stone.

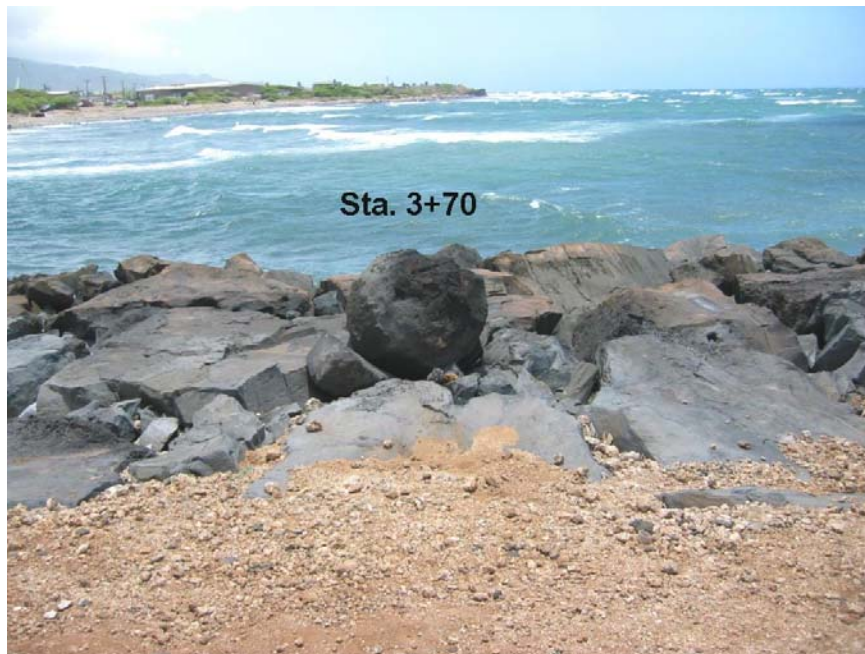
d. Sta 3+20, OS, Flipped armor stone.

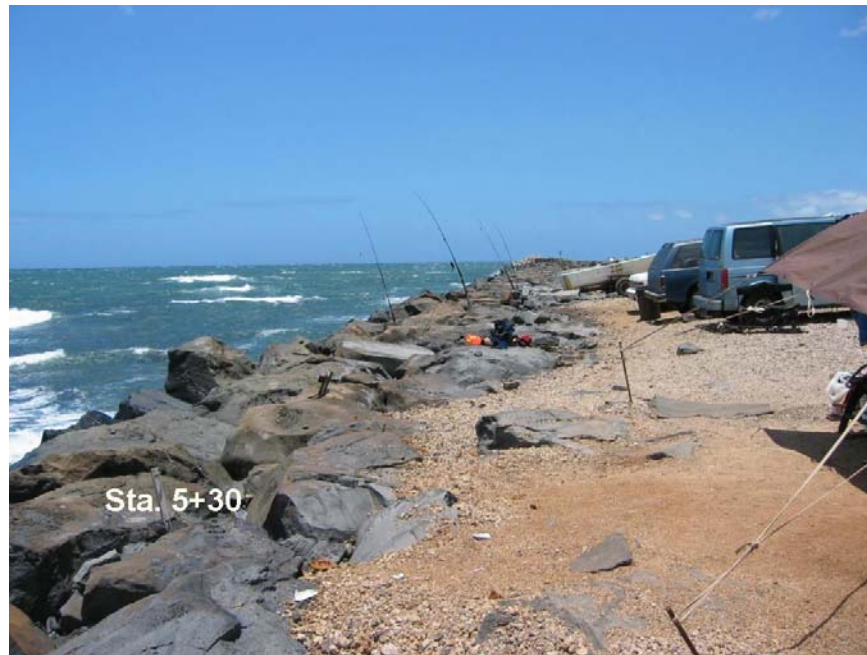
e. Sta 5+30, Overview of structure and adjacent area.

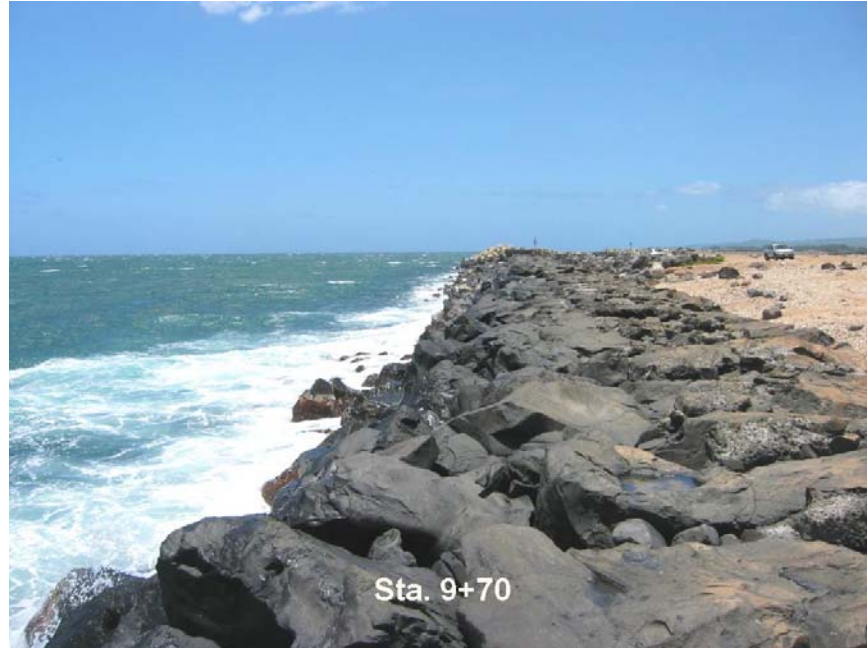
f. Sta 9+70, Overview of structure and displaced small stones.

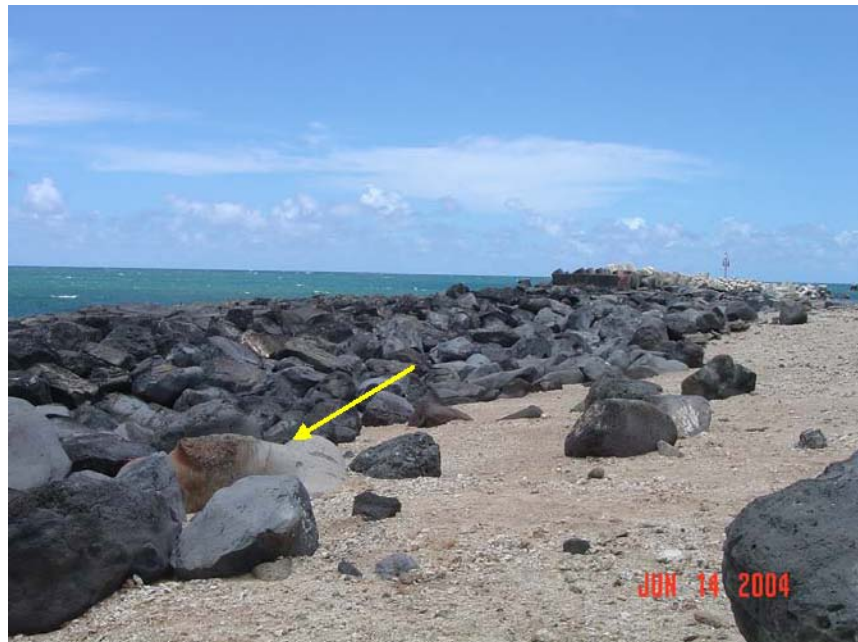
g. Tribar washed back from trunk of structure.

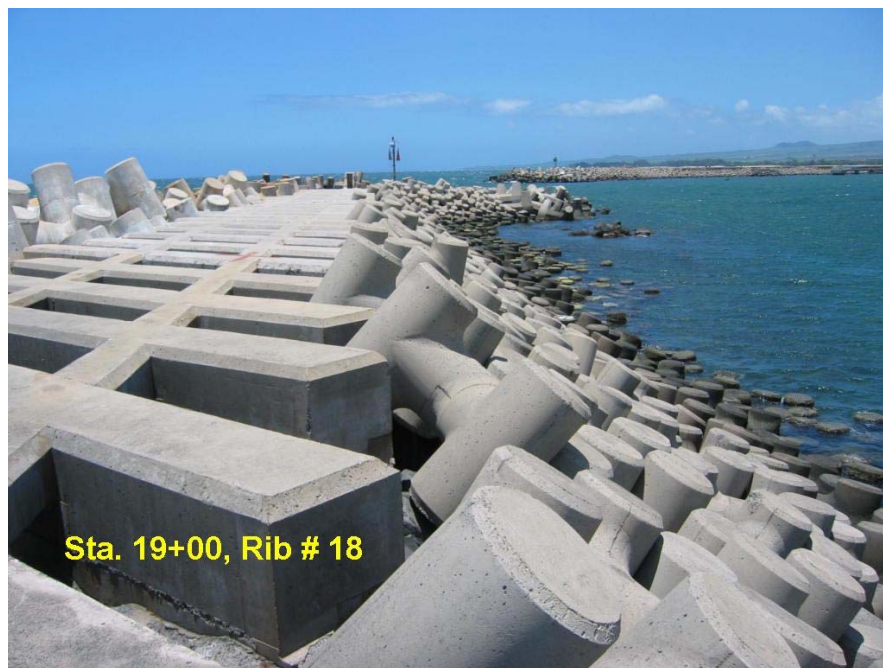
n. Sta 19+00 (Rib 18), HS, Overview.

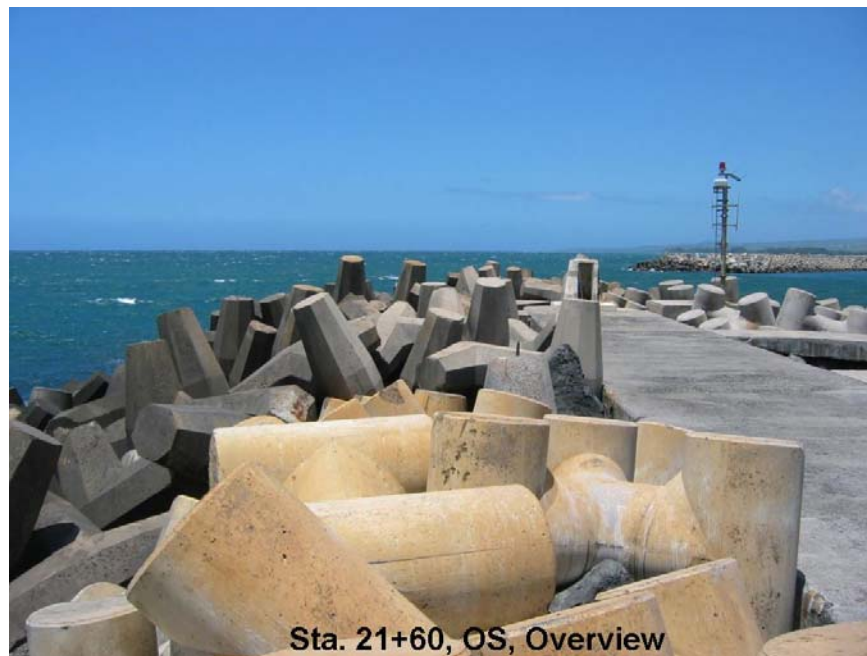
x. Sta. 21+60, OS, Overview to head.

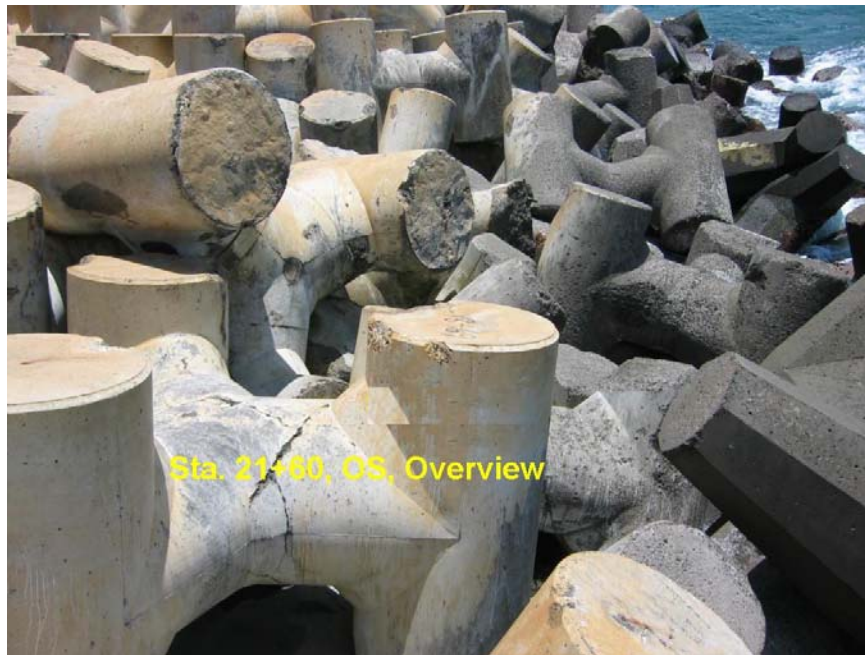
y. Sta. 21+60, OS, Overview toward root.

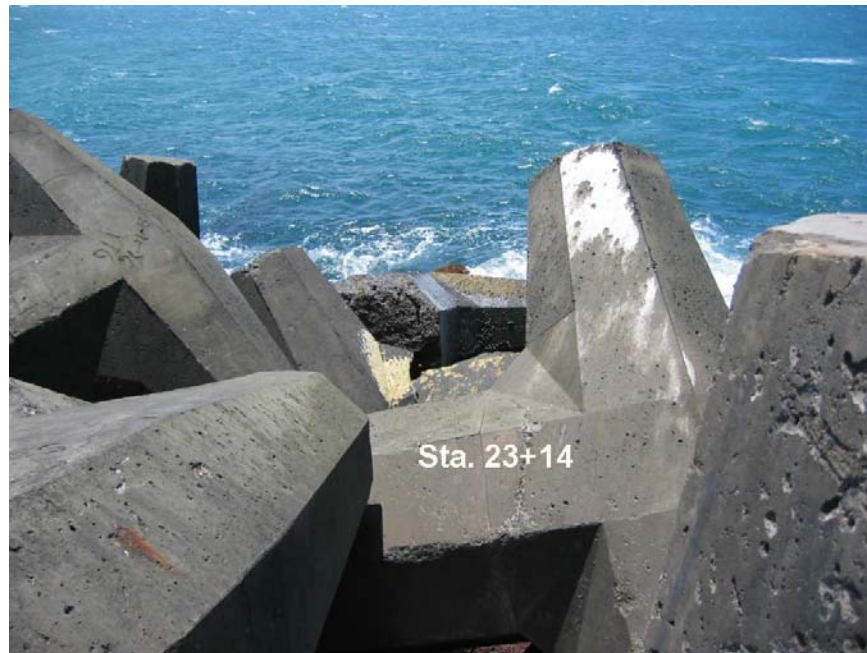
ee. Sta. 23+14, OS, 3 shank breaks.

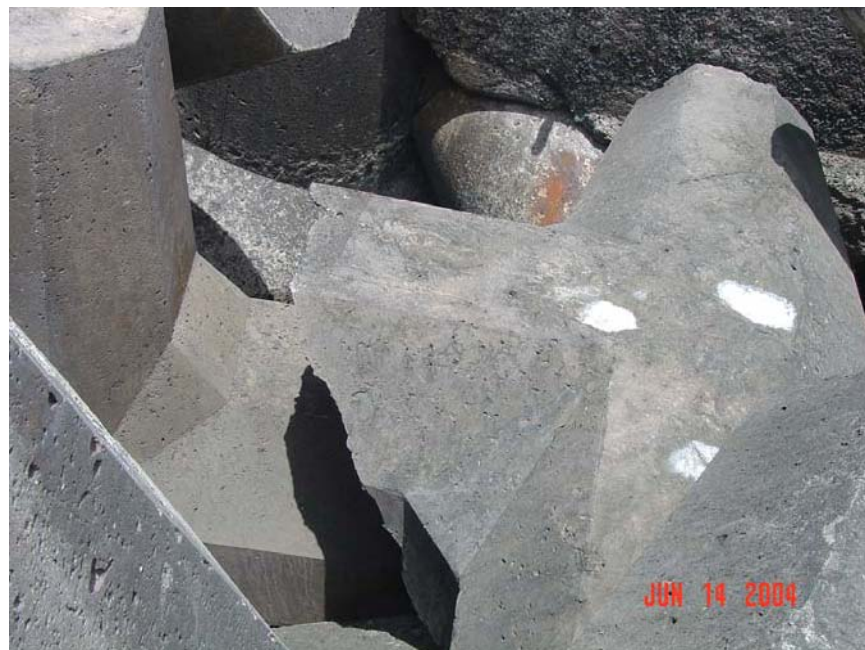
ff. Sta. 23+14, OS, 3 shank breaks.

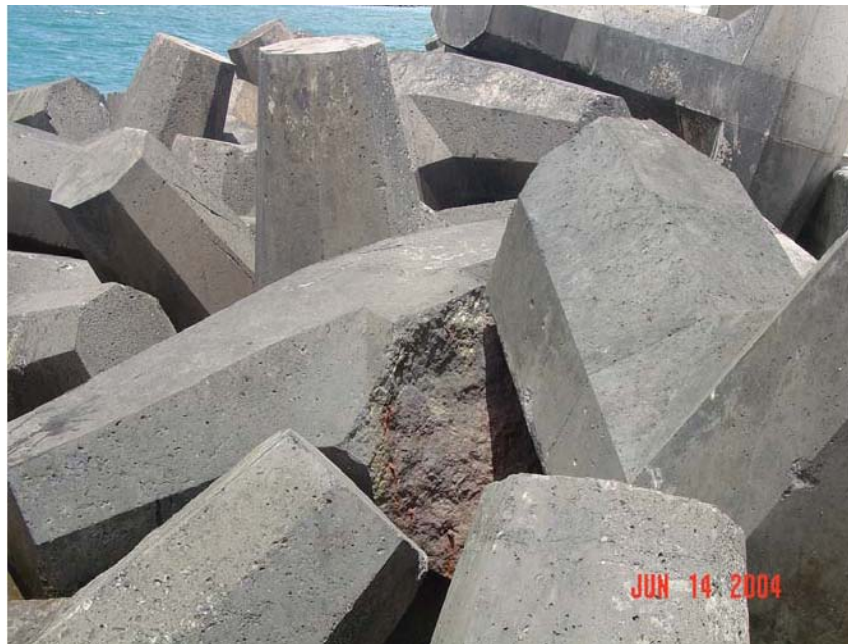
gg. Head, OS, 2 Shank breaks at 40 degrees.

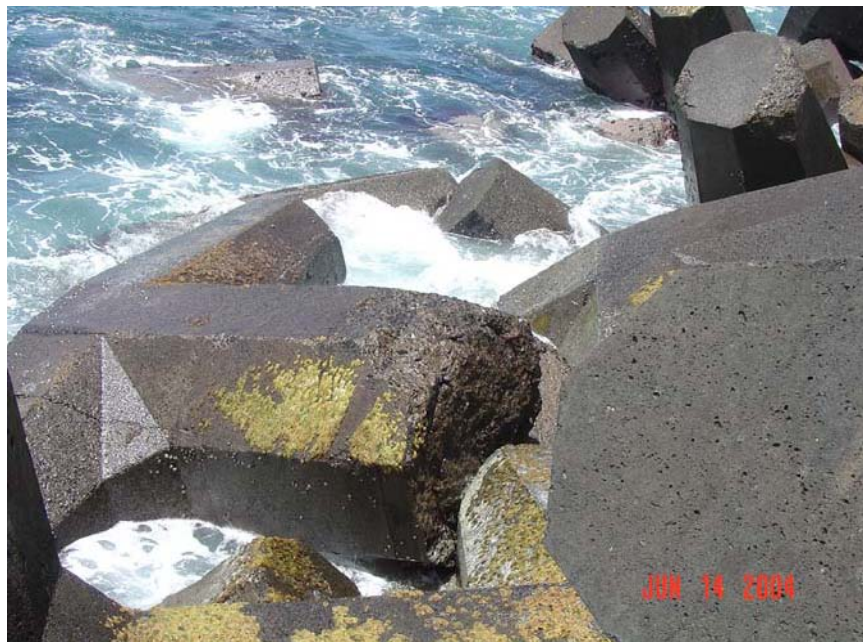
hh. Head, OS, 2 Shank breaks at 40 degrees.

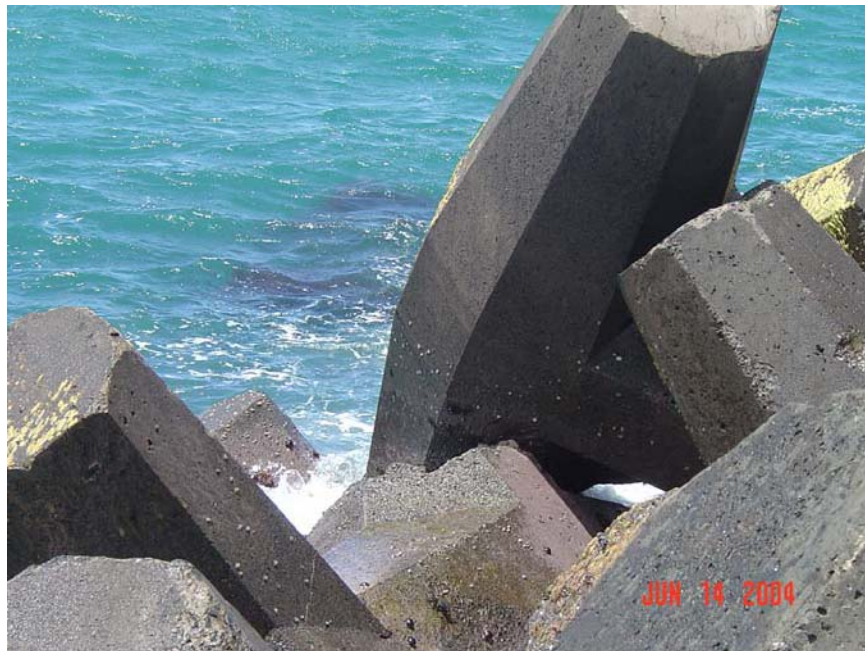
ii. Head, OS, 2 Shank breaks at 40 degrees.

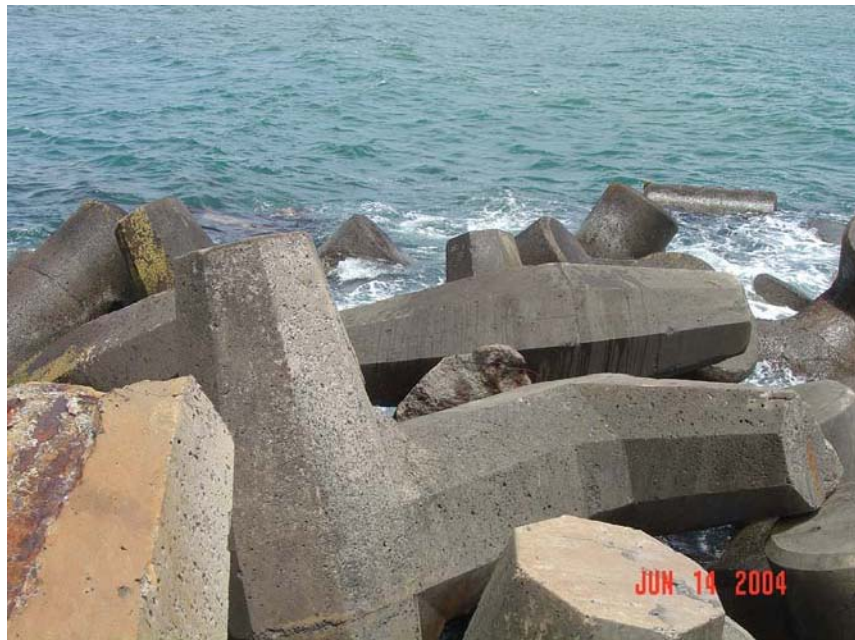
jj. Head, 10 degrees HS, Fluke break.

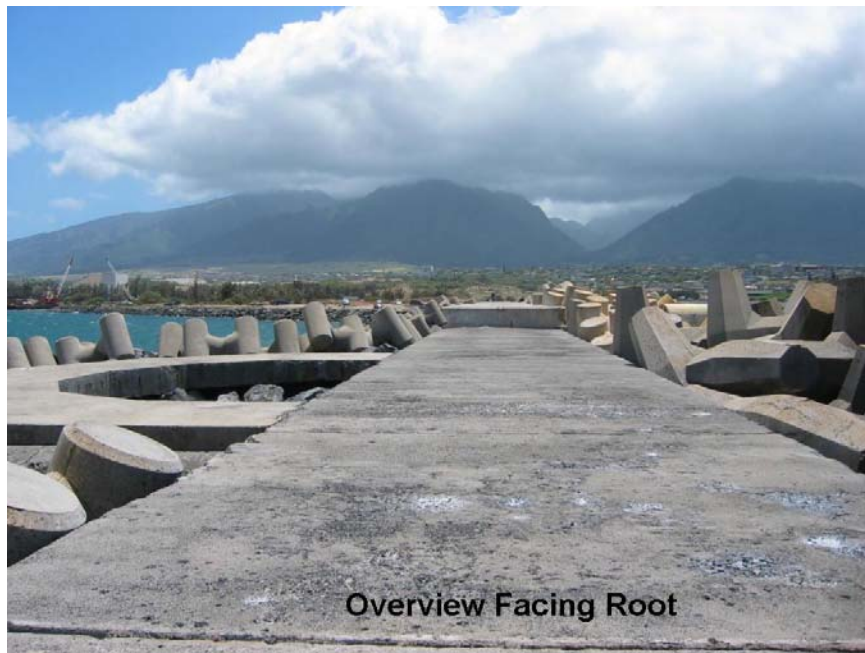
ll. Overview looking back from head.

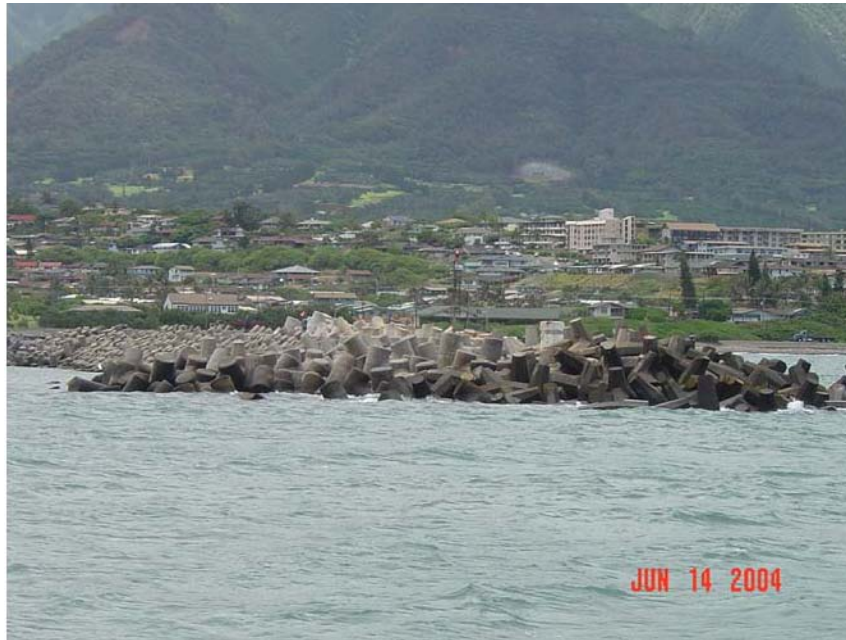
mm. Head of West Breakwater.
